Taylor Made  
SYSTEMS™

**M3** CANVAS  
CLIP

## M3 Engineering Tests & Results...

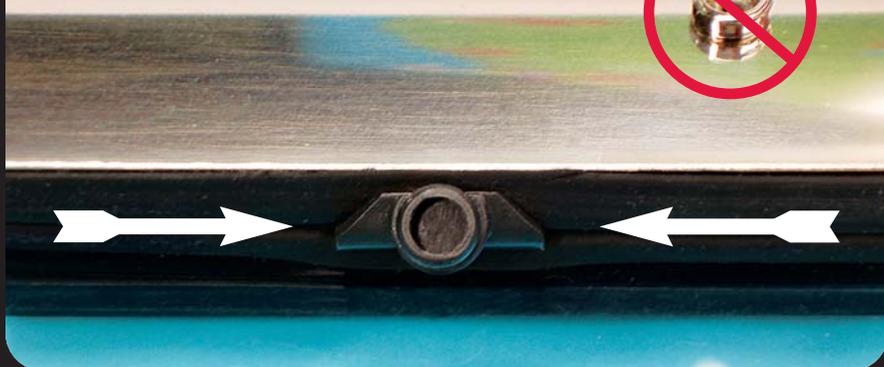
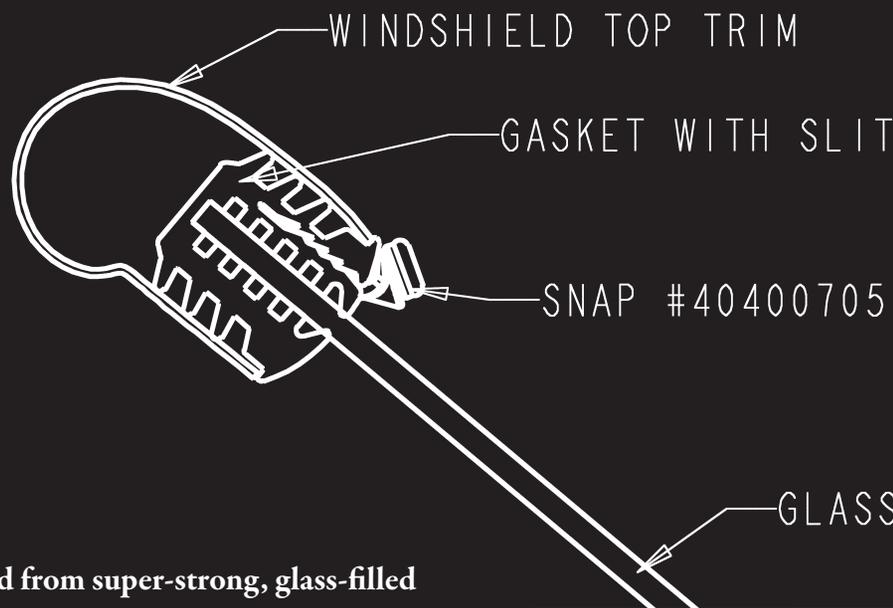
★ **The NEW M3 Canvas Clip vs. traditional stainless steel snaps...**

- ★ Patented!
- ★ Eliminates snaps traditionally located on the polished stainless steel top trim
- ★ Visually cleaner, sleeker look (no more “warts” blemishing the trim)
- ★ No more corrosion around drilled & riveted snaps
- ★ Reduces marring, scratching and makes it easier to clean and polish stainless steel header

- ★ Snap molded from super-strong, glass-filled nylon with a UV inhibitor
- ★ Easy to install (no drilling)
- ★ Inserts into a new rubber gasket
- ★ Movable!
- ★ Replaceable!
- ★ Available for a variety of trim profiles — both heavy and light — and different glass thicknesses

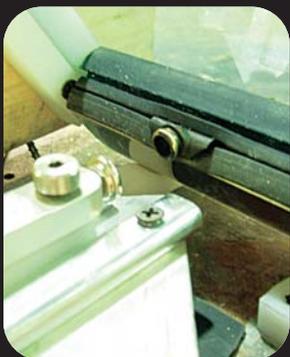
The M3 Canvas Clip was put through 10,000 cycles on a motorized tester (min. 13.5 years of use)...

TEST	DESCRIPTION/OBJECTIVE	RESULT	NOTES
Snap wear resistance test	10,000 cycles with motorized snap tester (If a boat owner removed and installed his boat cover two times a day, 365 days a year, it would take him over 13.5 years to cycle a snap this much).	PASSED	Snap showed an extremely small amount of wear but, otherwise, still looked and operated well.
Maximum load test	Strap with snap attached was pulled with a spring scale in-line (canvas has approx. strength of 80lbs/linear inch).	PASSED	Loads were taken up to 100lbs, exceeding canvas strength. The strap fabric tore, the M3 remained in place and intact.
Maximum load in-line w/vinyl slot test	Same as above but pulling in a direction that would yank snap directly out of vinyl slot (normally, snap would not have force in this direction, but it should hold some force and not break).	PASSED	Snap pulled out at about 20lbs with no breakage. Pushed snap back into rubber trim and it was back in action.

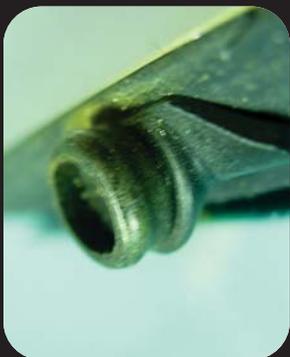
When finished, it was covered with metal shavings from the mating snap, but otherwise looked and operated well.

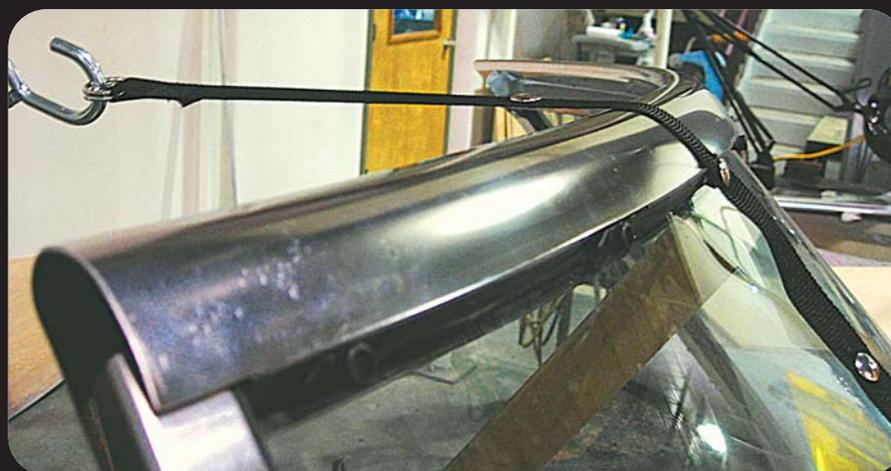
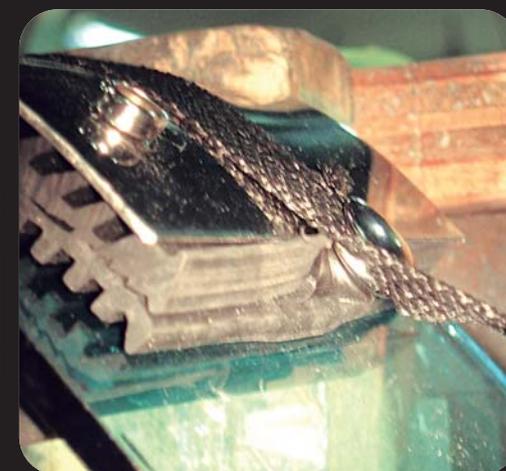
The M3 Canvas Clip exceeded a maximum load of 100 lbs. Canvas has an approx. strength of 80lbs/linear inch. Similarly, the strap that held the testing snap started to fray before a force greater than 100lbs. could be applied.
